Manhole Inspection Summary

Manhole # S21G__032MH

Insp Date: **8/27/07 7:36 AM**

Location Address: **32 MOUNT ST**

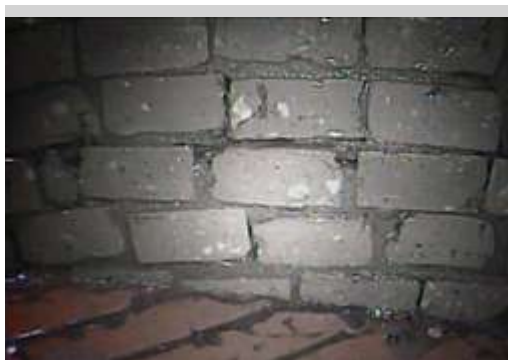
Defect 4

Barrel Material: **Brick** ☐ Parged
Shape: **Circular** Diameter: **46** (in.) Length: (in.)
Condition: ☒ Sound ☐ Cracked ☐ Root Intrusion ☐ Loose Brick ☐ Deteriorated
Infiltration: ☐ None ☐ Joint ☐ Cracks ☒ **Mortar** ☐ Roots ☐ Wall

MAJOR BARREL INFILTRATION

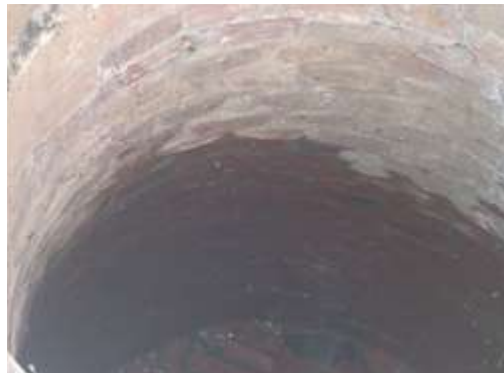
Defect 3

Corbel Material: **Brick** ☐ Parged Type: **Concentric/Eccentric**
Condition: ☒ Sound ☐ Cracked ☐ Root Intrusion ☐ Loose Brick ☐ Deteriorated
Infiltration: ☐ None ☐ Joint ☐ Cracks ☐ Mortar ☐ Roots ☒ **Wall**

INFILTRATION OF CORBEL

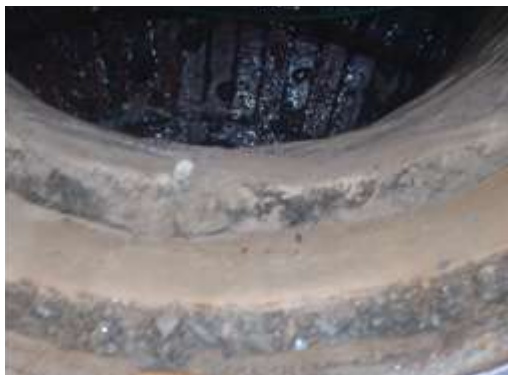
Defect 2

Frame Offset: **1** (in.) Condition: ☒ Sound ☐ Cracked ☐ Leaks

FRAME OFFSET

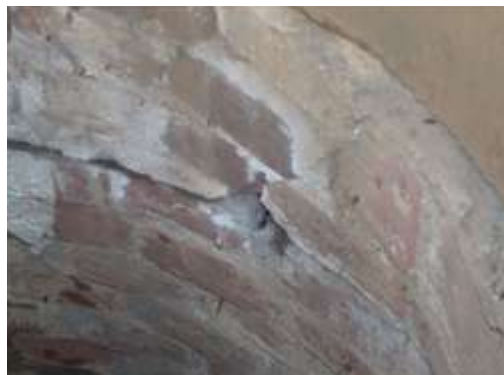
Defect 1

Chimney / Frame Adjustment ☒ Exists Material: **Brick** ☐ Parged Height: **9** (in.)
Condition: ☐ Sound ☒ **Cracked** ☐ Root Intrusion ☐ Loose Brick ☐ Deteriorated
Infiltration: ☒ None ☐ Joint ☐ Cracks ☐ Mortar ☐ Roots ☐ Wall

CRACKED CHIMNEY

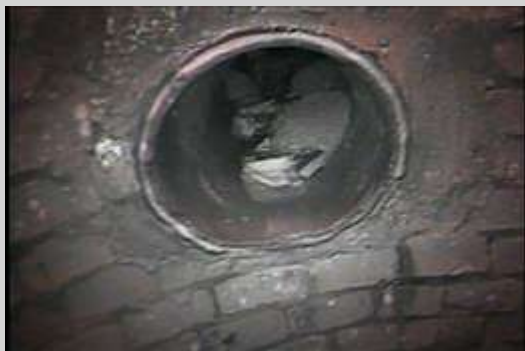
3 O'Clock Inflow

Pipe Height: **8.4** (in.) Rod and Bar (Angled)
Pipe Material: **Clay** ☐ Pipe Lined
Invert Depth: **7.41** (ft.) Flow Characteristics: **Slow**
Deposits: ☐ None ☐ Mud ☒ **Sludge** ☐ Debris ☐ Grease
Silt Depth: **1** (in.) Deposits Extent: **Light**
Infiltration: **None** Pipe Seal Cond: **Sound**
